Oroville Dam Failure:

1. **Nature of Failure:** Erosion of Emergency Spillway Channel on Downstream Face of Dam, and toe area of dam.
2. **Occurrence of Failure:** Upon the first ever use of the Emergency Spillway following storms, with more storms in the forecast
3. **Details and Size of Reservoir and Dam:**
<http://www.water.ca.gov/damsafety/docs/Jurisdictional2016.pdf> at Page 35 of 55.

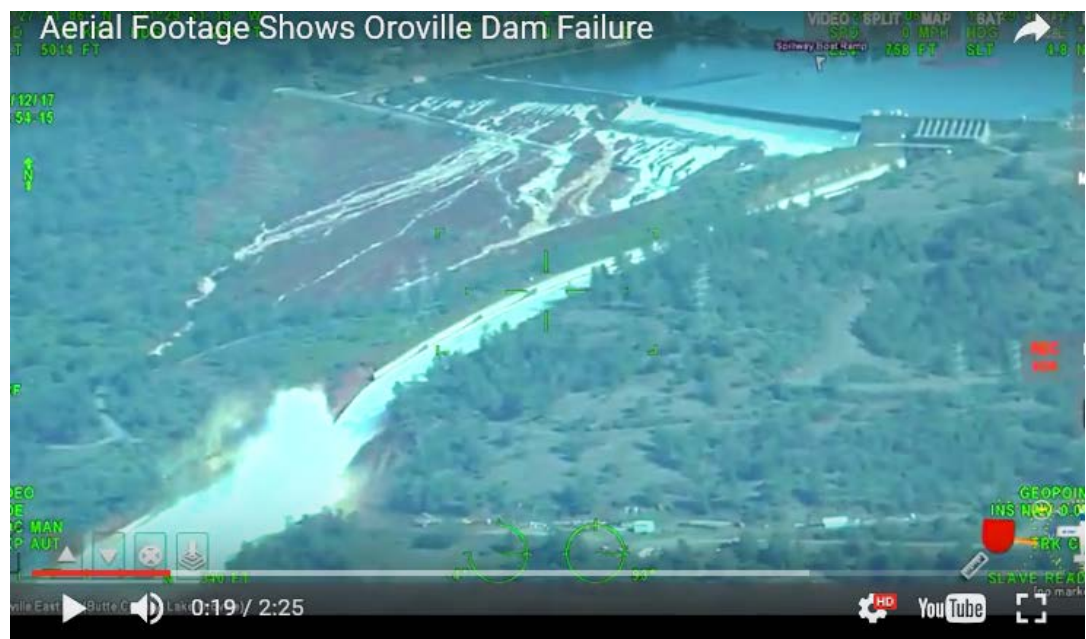
- c. **2/12/17 Video Capture:** Note water flowing on downstream face of dam and through the Emergency Spillway.
